CONDENSATION REDUCTION IN SECURITY CAMERAS: COMPARATIVE PERFORMANCE OF GORE® PROTECTIVE VENTS VERSUS DESICCANTS

By Boris Pak L. Su, Zhi R. Cui and Hong Y. Yu*

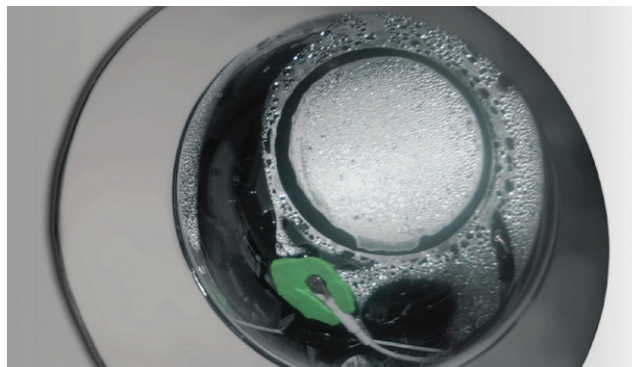
Figure 1: Desiccant could not prevent severe condensation from forming and becoming trapped within this sealed enclosure.

- 2) Subsequently, sealed camera enclosures were adopted to meet IP66 requirements. Since the sealed environment itself promoted the formation of condensation, desiccant packs were introduced before sealing the enclosure. However, desiccant packs have a limited effective life, and end-users must periodically replace them. This can be time-consuming and costly, due to the installation height of most outdoor security cameras.

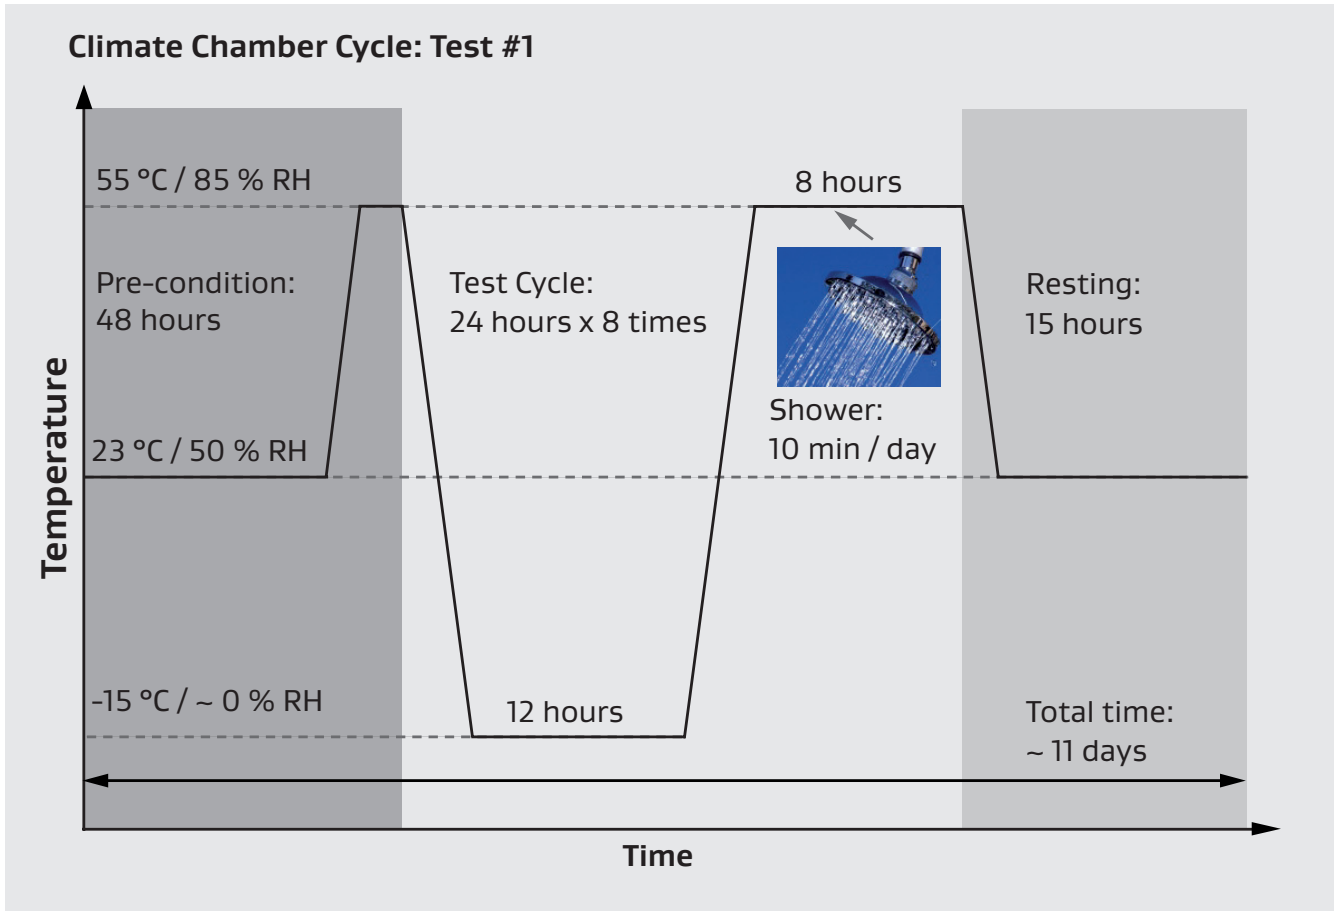
Figure 4: This climate chamber test simulated the changing weather conditions that can affect outdoor cameras.

This test employed a temperature and humidity cycle extending from -15 °C / 0 % RH to 55 °C / 85 % RH. This cycle incorporated a 10-minute water shower, to simulate rain.

Over the course of eight such cycles, images were recorded from each camera as well as the humidity inside each camera enclosure, in order to monitor the levels of condensation.

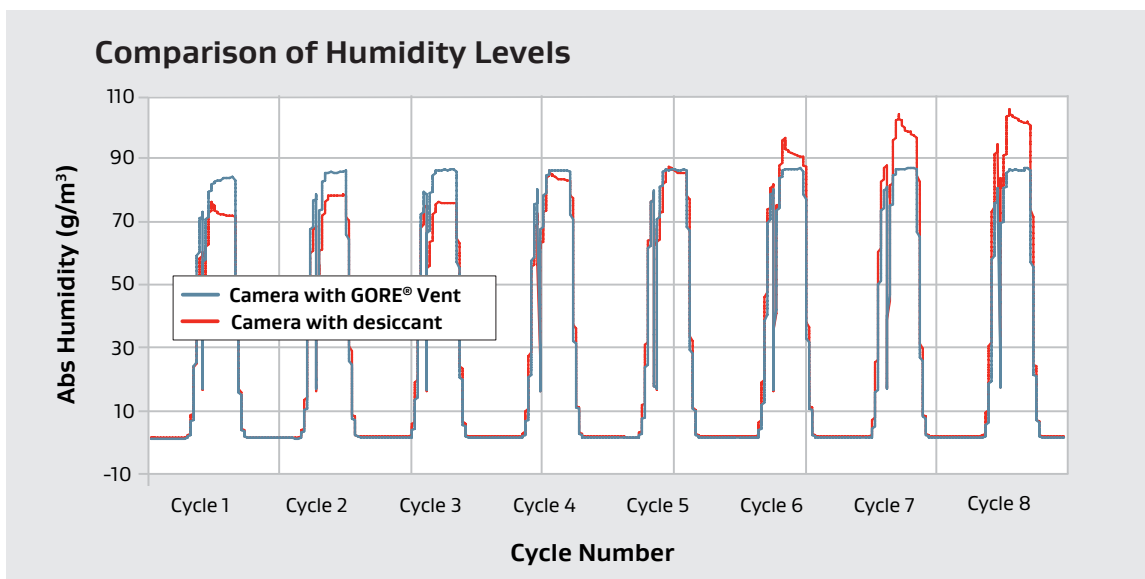
Figure 6: Beginning at Cycle 6, the fully-saturated desiccant releases moisture, causing a significant increase in humidity levels within the enclosure.

The recorded humidity levels within each camera enclosure also showed important differences. While humidity within both enclosures increased in response to climate chamber conditions, the camera with desiccant shows a significant humidity increase, beginning at Cycle 6. This is because the desiccant moisture absorption process reverses itself after several cycles of high humidity. At Cycle 6, the desiccant was fully saturated and began releasing water back into the camera enclosure, creating the condensation it was intended to combat.

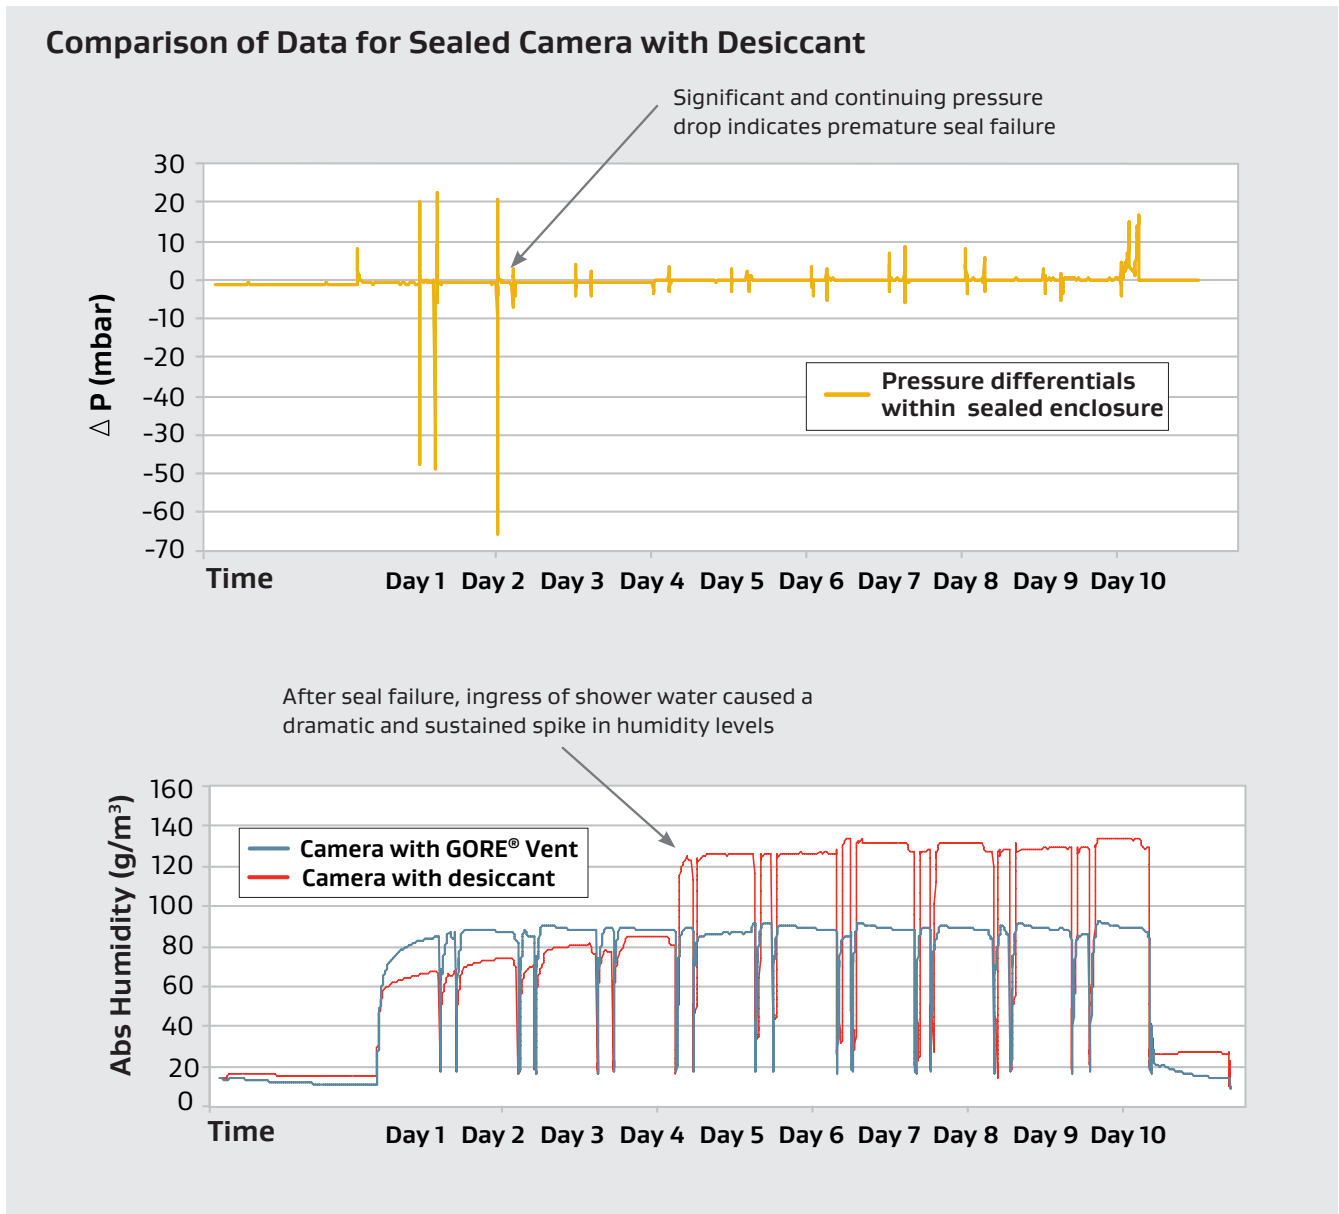
Figure 8: Because the sealed enclosure could not equalize pressure differentials, the seal was stressed to failure in just two days.

As shown in Figure 8, after Day 2, pressure differentials in the sealed camera diminished dramatically. Subsequent examination showed that the strong initial pressure differentials had stressed the seal to the point of failure.

The subsequent temperature drops (induced by the water shower) created negative pressure within the enclosure, drawing ambient air and shower water in through the failed seal. The desiccant could not counteract this trapped moisture.

Thus, excessive condensation formed on the lens, seriously degrading the image quality. In the other camera, the GORE® Vent rapidly equalized pressures, so the seal for that enclosure was not stressed to the point of failure. Since the vented enclosure's seal remained intact, there was no ingress of shower water to degrade image quality. The camera with the GORE® Vent retained consistently good image quality throughout this test.

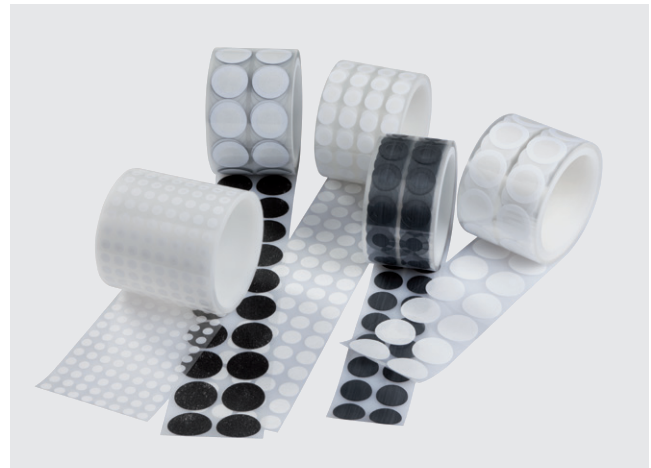
Figure 9: These flexible, low-profile vents are easily installed.
